A New Method for Monitoring Gears Surface Failures Using Enhanced Image Registration Approach

Onsy, Ahmed, Fouad, Mohamed, Shaw, Brian and Dansereau, Richard M.

Onsy, Ahmed ORCID: 0000-0003-0803-5374, Fouad, Mohamed, Shaw, Brian and Dansereau, Richard M. (2014) A New Method for Monitoring Gears Surface Failures Using Enhanced Image Registration Approach. SAE International Journal of Aerospace, 7 (1). pp. 182-189.

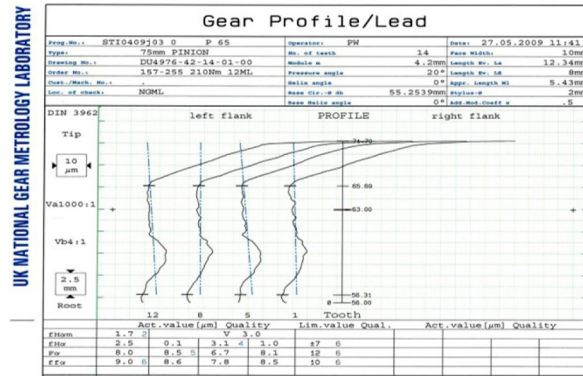
It is evident that the flanks of the test gears scuffed significant as a result of surface fatigue during continuous running at relatively high torque/contact stress. To quantify the damage on the gear flanks, profile deviation was measured on 4 teeth per gear using a gear measuring machine. The records of gear profile measurements at the end of stage 1 of the test and at the end of stage 3 respectively are shown in [Figures 6](#) and [7](#). The gear involute measurements confirm the results of the IR approach.

Figure 6(a). Pinion profiles of 4 teeth after test day 3. The maximum profile deviation caused by micro-pitting is evaluated as around 10 µm.

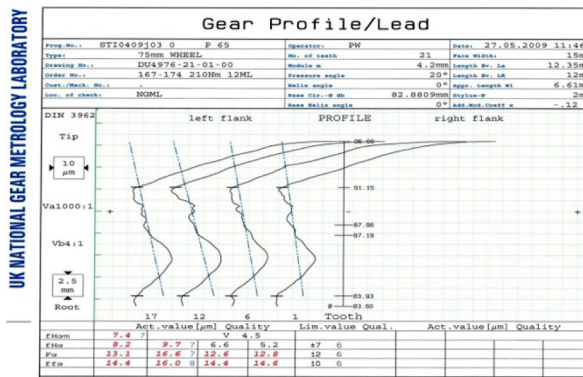
Figure 6(b). Wheel profiles of 4 teeth after test day 3. The maximum profile deviation caused by micro-pitting is evaluated as around 15 µm.
